LR-N04-0341

**FIRST REVISED NRC ORDER EA-03-009:
REACTOR PRESSURE VESSEL HEAD AND VESSEL HEAD
PENETRATION NOZZLE POST OUTAGE INSPECTION RESULTS
SALEM GENERATING STATION UNIT 1
FACILITY OPERATING LICENSE NO. DPR-70
DOCKET NO. 50-272**

Salem Unit 1-1R16 Reactor Vessel Head Penetration Examination

WDI-PJF-1302611-FSR-001

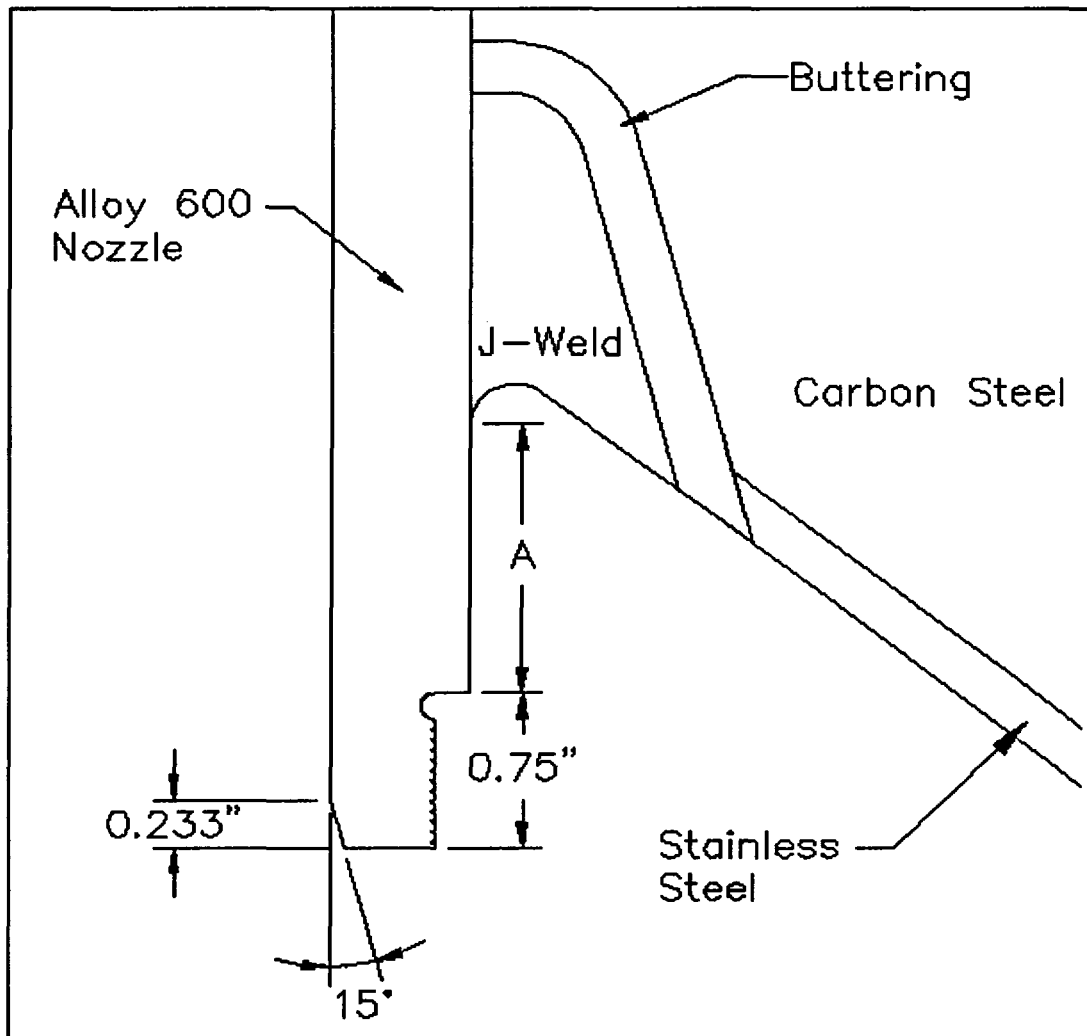
The configuration of the Salem Unit 1 CRDM penetration tubes is shown in the figure below. This figure represents the tube-to-head geometry on the "downhill" side of the tube (0° azimuth of the penetration). The bottom ends of all seventy-nine penetration tubes are threaded on the OD surface and have a 15° chamfer on the ID surface.

The threads on the OD surfaces extend from the bottom of the tube to an elevation of approximately 0.6875" where there a thread relief is machined. The top of the thread relief is 0.75" above the bottom of the tube. The distance from the top of the thread relief to the bottom of the fillet of the J-groove weld (identified as "A" in the figure) varies based on location of the penetration in the head. These distances are longer for penetrations at "inboard" locations and become progressively shorter for penetrations located further away from the center of the head.

The threads on the tube OD surfaces and chamfer on the ID surfaces represent geometric conditions which limit examination coverage near the bottoms of the tubes.

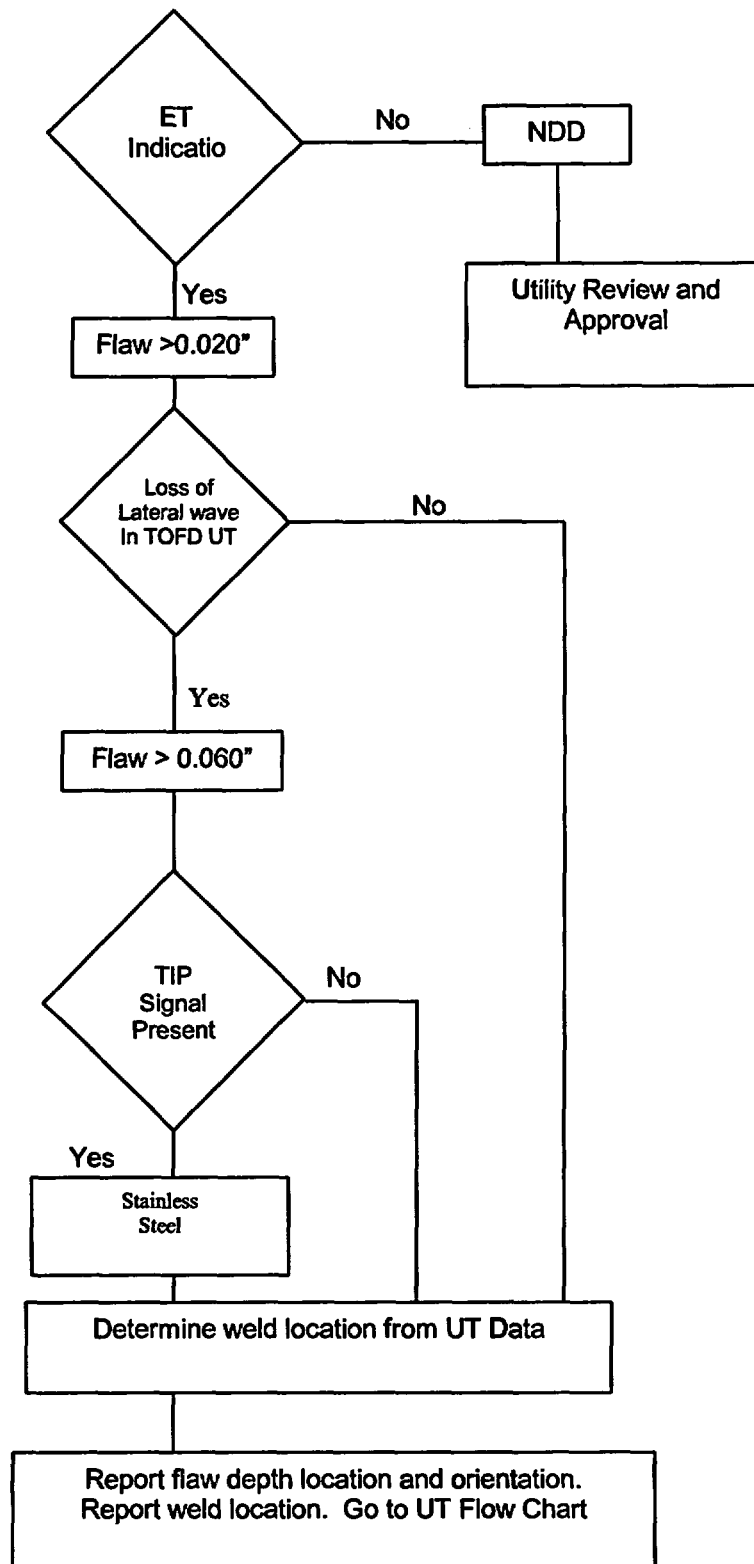
Figure 5-1 - Penetration Tube ID Flaw Evaluation

Eddy Current results from tube ID surface examinations showed 15 penetration tubes with indications characteristic of axial cluster cracking. With the exception of penetration #19 these indications were determined with the TOFD inspection to have a depth less than 0.040". Penetration #19 had indications characteristic of axial cluster cracking as described above. One indication in the cluster area had a reflector which produced a measurement of 0.047" with the TOFD inspection channel.

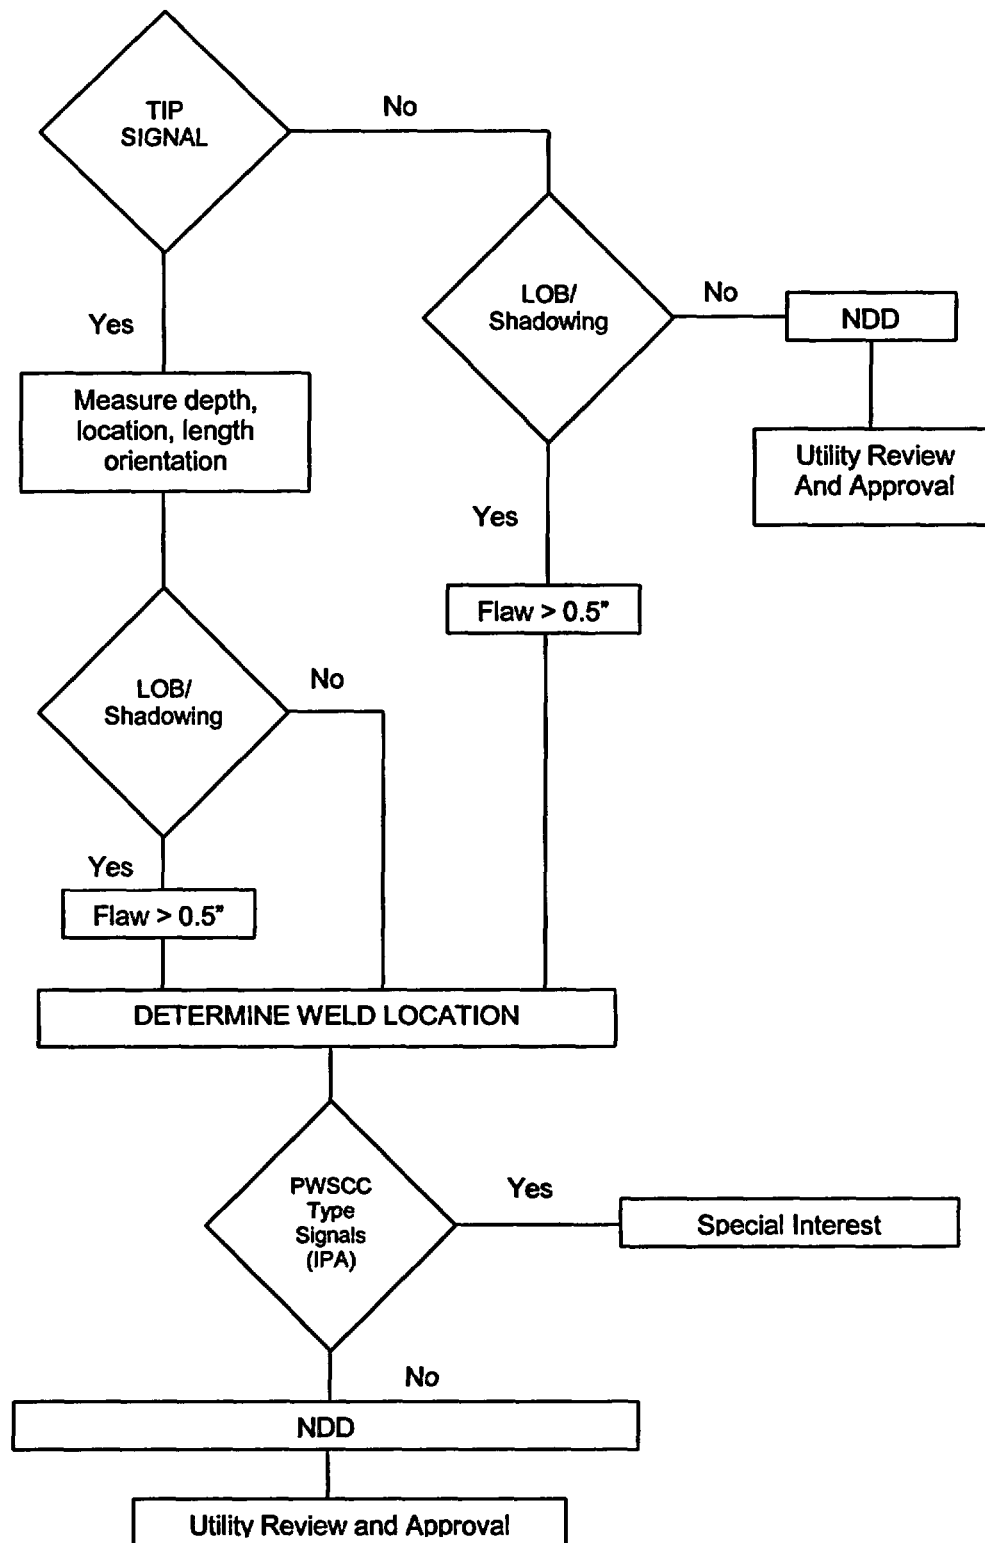
Figure 5-2 - Penetration Tube OD Flaw Evaluation

Results from the TOFD ultrasonic and eddy current examinations of the sixty-nine reactor vessel head penetrations identified no indications characteristic of PWSCC. The straight beam ultrasonic examinations of the shrink-fit regions of the seventy nine penetration tubes showed no evidence of leak paths.
